# ACCUMULATED FORCE ON SHEATH DILATOR CAUSED CATASTROPHIC EVENT DURING PARAVALVULAR LEAKAGE CLOSURE AFTER TAVR WITH TORTUOUS AORTA

Hidehiko Hara MD <sup>1</sup>, Go Hashimoto MD<sup>1</sup>, Takeshi Arita MD <sup>2</sup>

1 Toho University Ohashi Medical Center, Tokyo JAPAN

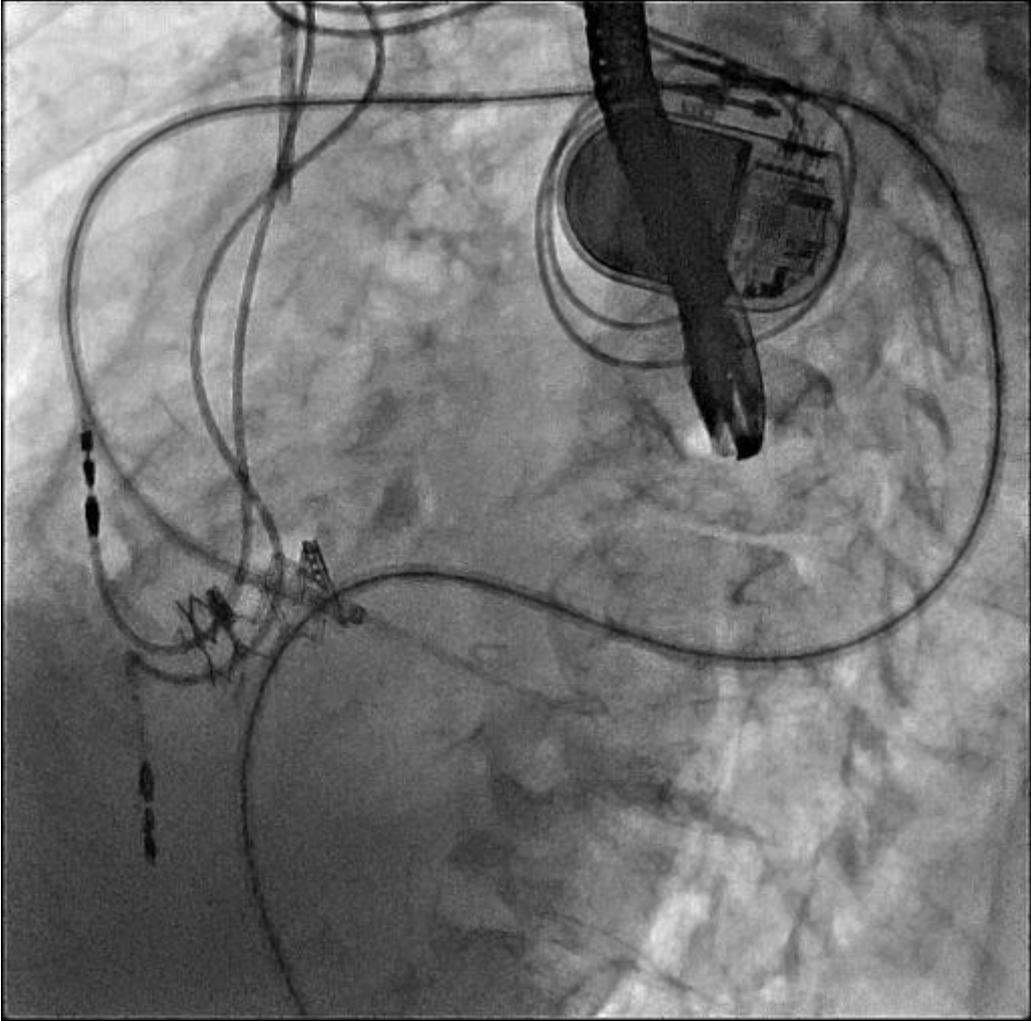
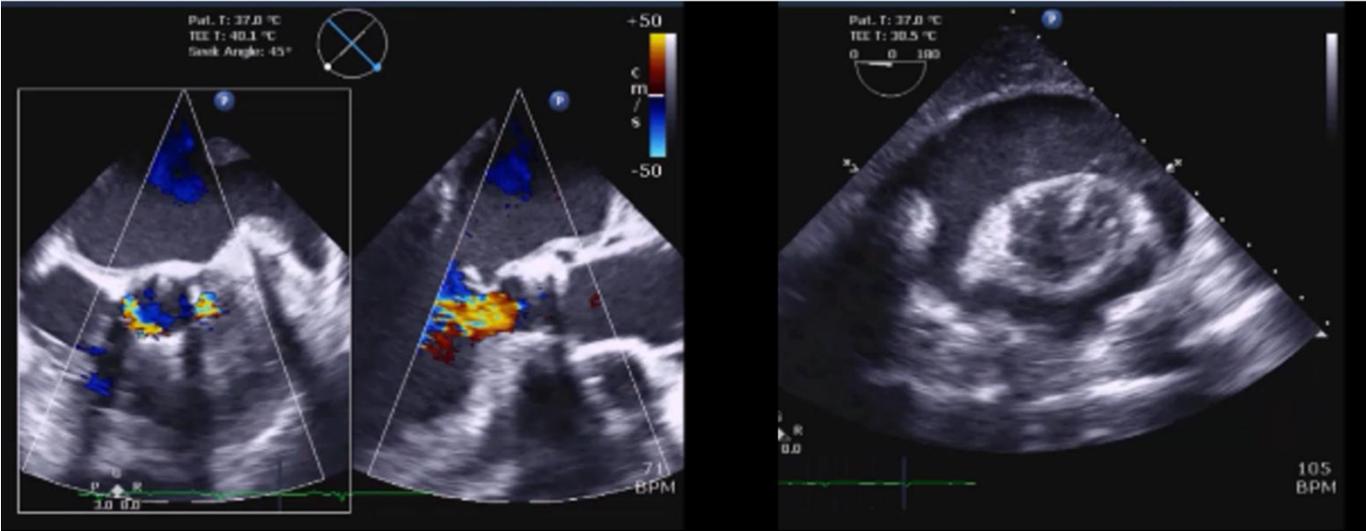
Echo revealed severe PVL from 2 regions. One located at lesser curvature, and the other was at greater curvature of Valsalva. Fluoro imaging showed extremely elongated tortuous aorta.

6Fr. long sheath with telescoping system was delivered above aortic valve and glide wire was inserted into LV through the leakage on greater curvature first. Occlutech PLD W device was inserted into sheath but the meandering aorta made it difficult, so it was very hard to advance the device itself through the curved sheath. PLD T 3x4 was finally implanted after changing the thicker sheath. Next, long sheath with AMPLATZER L1 diagnostic catheter aimed LV inside through lesser curvature of Valsalva where located another leakage. Once wire was changed to super stiff one, but the 7 Fr. Glide sheath could not go through the SAPIEN. Right after pushing as much power as possible, the curved sheath suddenly started moving forward and with stiff wire, it penetrated LV wall before sheath was pulled back. The patient had cardiac tamponade so that we proceeded implantation with AVP4 during drainage. After coming back to ICU, the patient revealed cardiac arrest and died even after successful surgical repair of the LV wall.

The Occlutech PLD device might not have been suitable for the PVL after TAVR because of the shorter length of the device. Besides, the devices require larger sheath which may make difficult to go through the leakage using thicker sheath. When treating with the PVL closure at the lesser curvature

of the Valsalva of the aortic position, we should reconsider the approach site like brachial or subclavian artery because of easier degree for sheath insertion.
